Study on the Issue of Veneer Cracking in the Kitchen Cabinet and Furniture Industry

Value to Wood Report FPI-11-01

Final Report 2011-2012

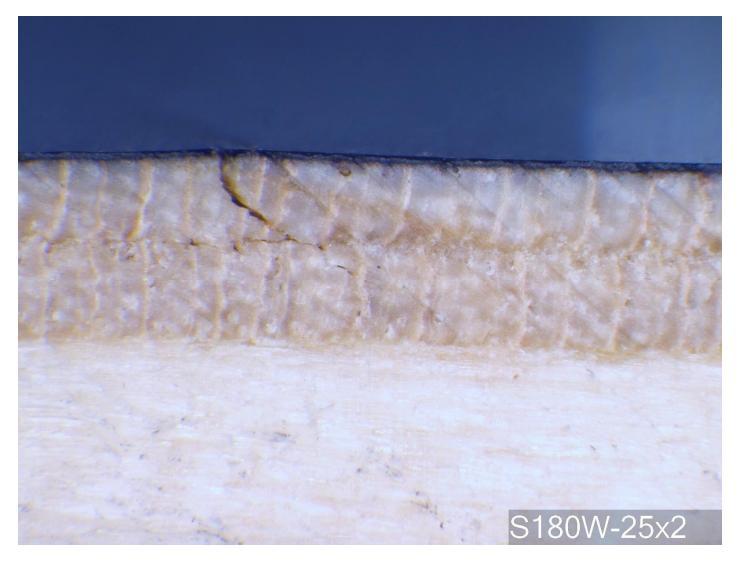
- Observation of cracks on the convex side of curved panels
- Cracks running with the wood grain
- Raised edges of cracks
- No finish inside the cracks
- Average depth of cracks greater than the thickness of the surface finish
- 4-ply construction substrate made of three different types of wood

Figure 7 Surface crack on a curved panel

Various examinations and laboratory tests led to the hypothesis that the cracking was caused by high humidity in certain components (plies) of the plywood when the components were manufactured and finished.

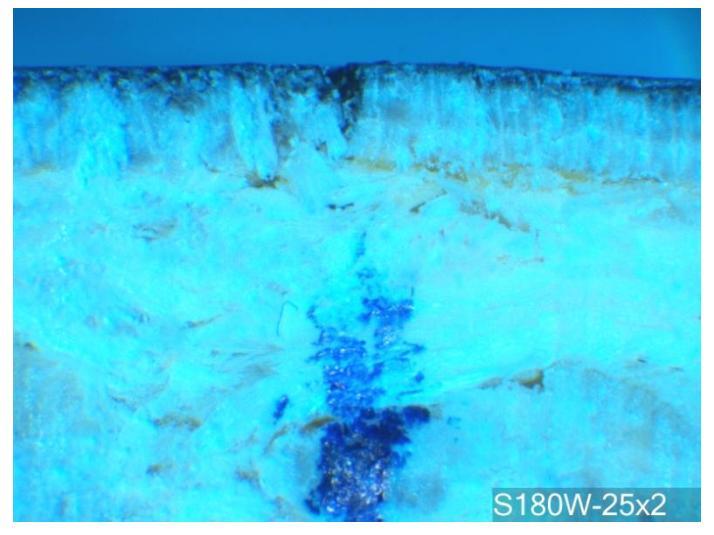
- Cracks are isolated, with a limited number on the panel
- Cracks can reach a length of 10 cm
- Edges of cracks are more or less raised
- Finish is present in the cracks
- Good adherence between the veneer and the substrate near the cracks (Figure 9)

Figure 8 Cross-section of a type 1 crack

The first type is characterized by isolated, relatively long cracks in the surface of the component. These cracks may be explained by poor handling of the veneer before gluing, or by the handling of components

with veneer glued to thin substrates. It is recommended that the client handle veneer and components with care to avoid curving.

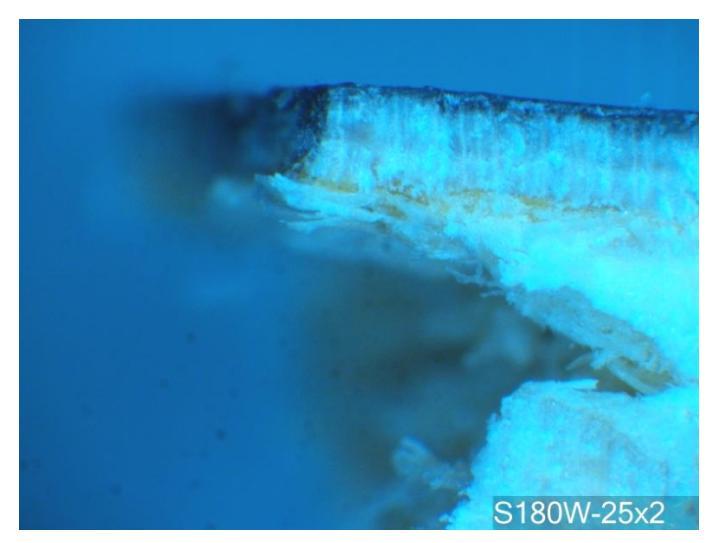
Figure 9 Cross-section of a test panel after the panel was broken in two

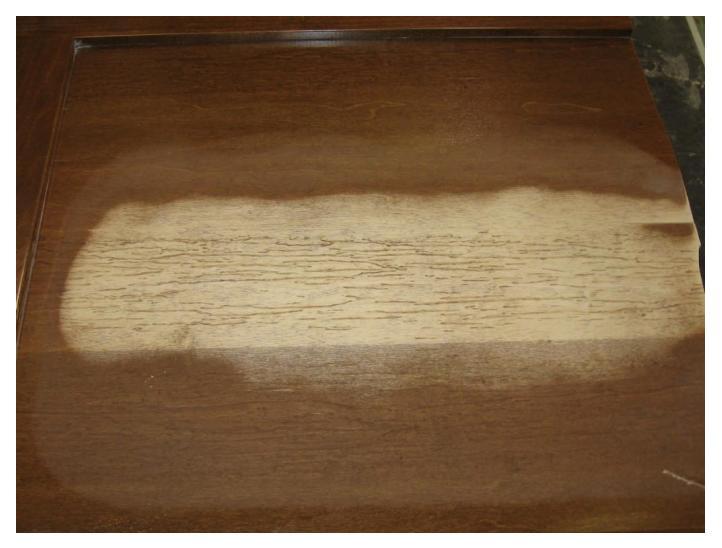
- Cracks 1 to 3 cm long with non-raised edges
- Cracks mainly present in mineral striations
- Finish present in cracks
- Good adherence between the veneer and the substrate near the cracks

Figure 10 Sanded surface of a component with striations on the veneer surface

The second type of crack is characterized by its short length and its high numbers on the veneer surface (Figure 10). This type of crack can be explained by veneer shrinkage after gluing due to high initial

humidity content. It is recommended that the client control the humidity content of the veneer before gluing. Veneer with mineral striations is very prone to surface cracks and should be avoided.

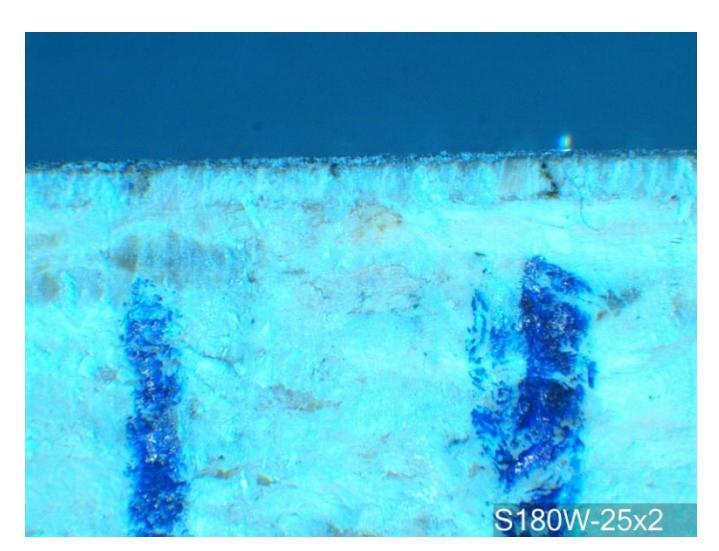
Figure 11 Cross-section of type II cracks

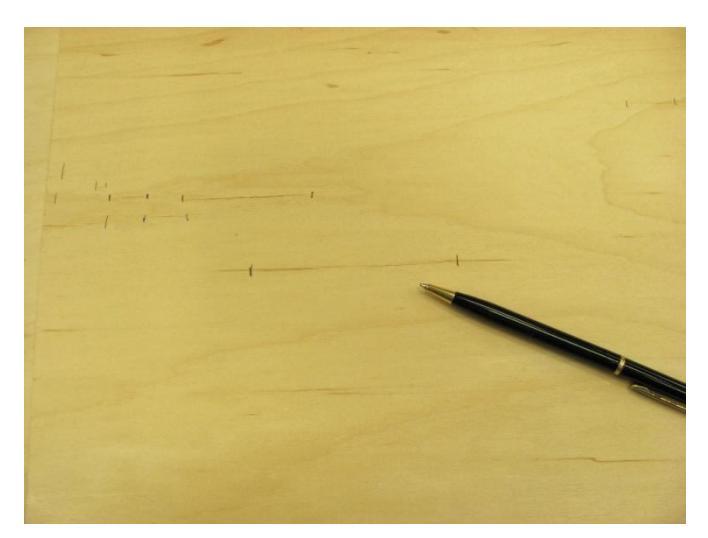
Figure 12 Cracks observed on unfinished veneer

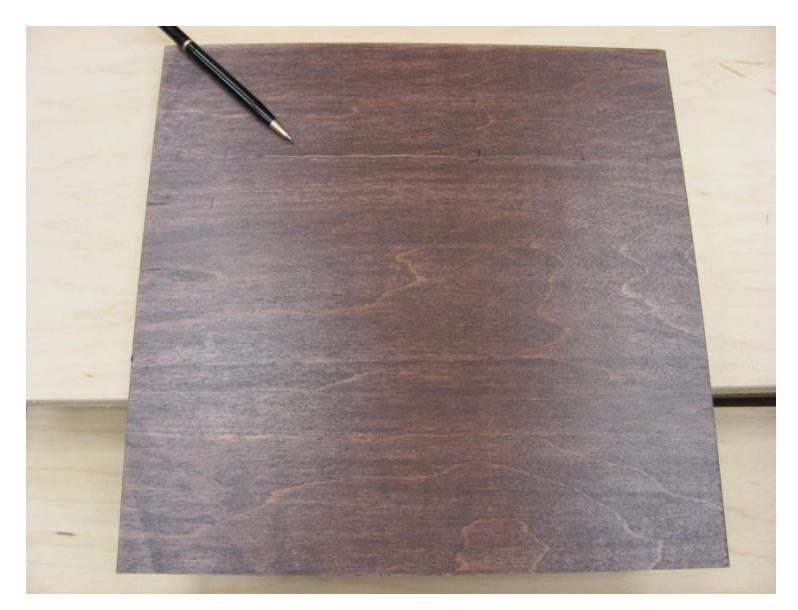
Figure 13 Cracks observed on finished veneer
